Manhole Inspection Summary

Manhole # S15C1_002MH

Insp Date: **4/16/09 3:08 PM**

Location Address: **2930 JAMES ST** Cross Street: **INVERNESS AV**

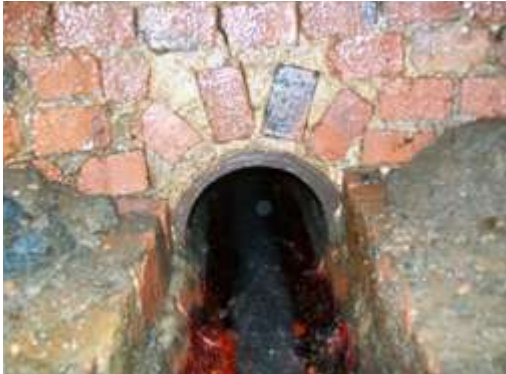
Defect 2

Infiltration: ☐ None ☐ Joint ☐ Cracks ☐ Mortar ☐ Roots ☒ **Wall**

BARREL WALL INFILTRATION

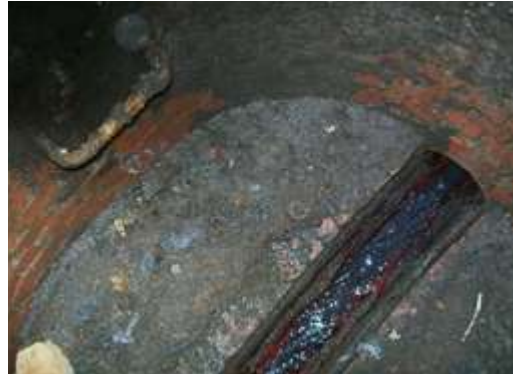
Defect 1

Condition: ☐ Sound ☐ Cracked ☐ Root Intrusion ☐ Deteriorated ☐ Leaks ☒ **Debris**

Steps Count: **4** Missing: **0** ☒ **Corroded**

DEBRIS ON BENCH, CORRODED STEPS

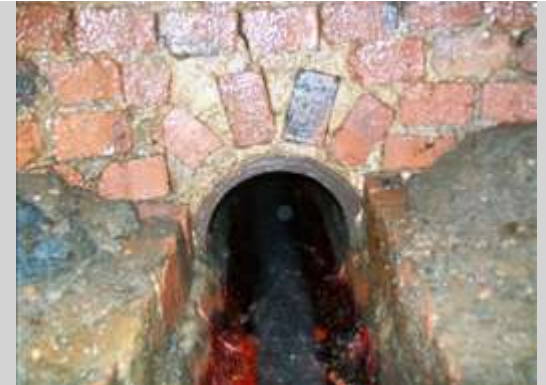
12 O'Clock Outflow

8 in. Circular Gravity Sewer
Pipe Out @ 12 O'Clock

Pipe Height: **8.4** (in.) Rod and Bar (Angled)
Pipe Material: **Clay** ☐ Pipe Lined
Invert Depth: **8.89** (ft.) Flow Characteristics: **Slow**
Deposits: ☒ None ☐ Mud ☐ Sludge ☐ Debris ☐ Grease
Silt Depth: **0** (in.) Deposits Extent:
Infiltration: **None** Pipe Seal Cond: **Sound**

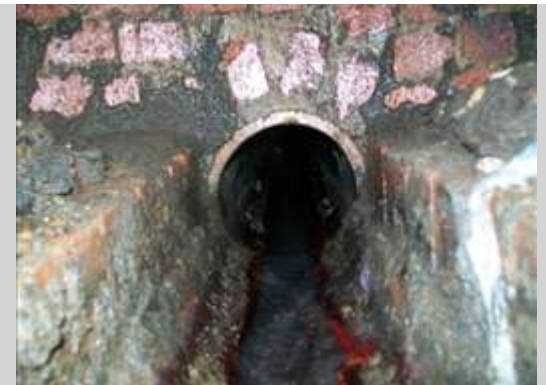
6 O'Clock Inflow

8 in. Circular Gravity Sewer
Pipe In @ 6 O'Clock

Pipe Height: **8.4** (in.) Rod and Bar (Angled)
Pipe Material: **Clay** ☐ Pipe Lined
Invert Depth: **8.75** (ft.) Flow Characteristics: **Slow**
Deposits: ☒ None ☐ Mud ☐ Sludge ☐ Debris ☐ Grease
Silt Depth: **0** (in.) Deposits Extent:
Infiltration: **None** Pipe Seal Cond: **Sound**
